OHS ALERT

RAIMONDI CRANE ALERT

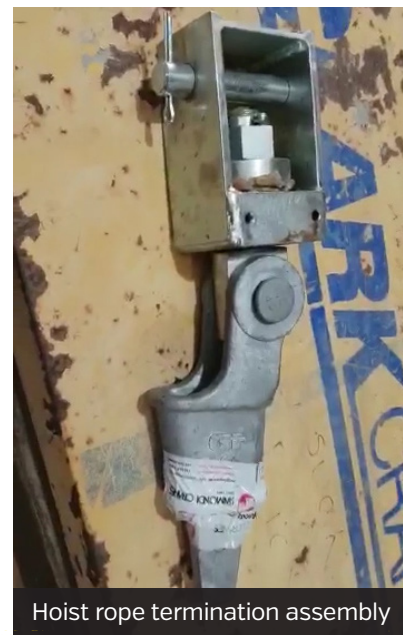
WorkSafe investigators suspect that the failure or malfunction of the hoist rope termination assembly, also known as the wedge socket, is likely to have been a contributory factor in the incident.

Hoist rope termination assembly

All owners, hirers and operators of all cranes must engage appropriately qualified and experienced personnel, to immediately inspect their hoist rope termination assemblies, to ensure they are appropriately

installed, compliant and functioning according to manufacturer's specifications, and to consider engaging further specialist advice if they are unsure.
