# SAFETY ALERT

## Swing Away Folding Jib

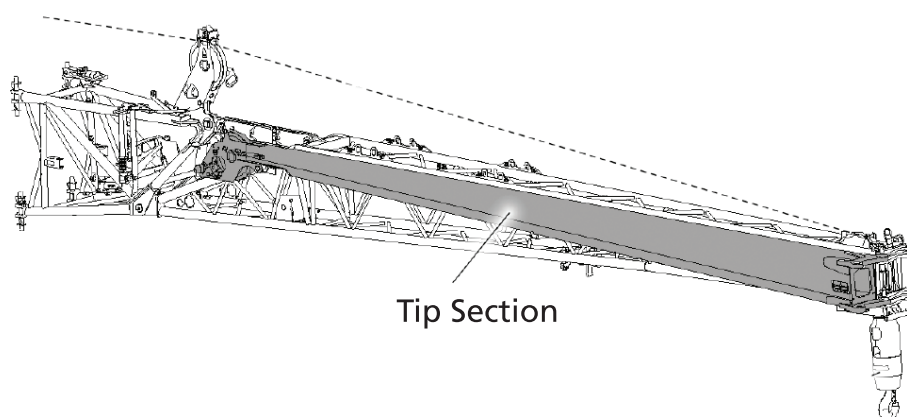
During transport (not on crane) a Swing Away Folding Jib opened with the tip section entering the live lane while the transporter was traveling at 90Km/Hr.

1. Secure the tip section directly to the base section to support the tip section from leverage during transport.
2. Ensure securing prevents the tip sections ability to open during transport operations.

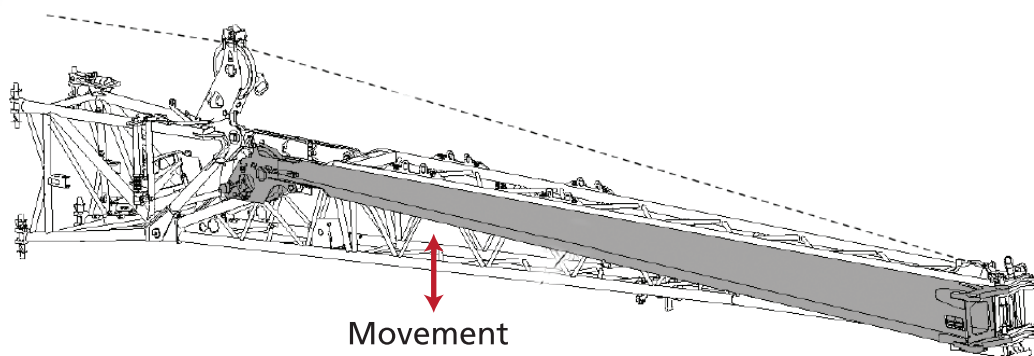
The load was secured to the transporter by a single strap at the front and another single strap at the rear of the Jib. The tip section was secured using only the manufacturers pinning mechanism and components.

In this transport configuration the tip section is leveraged by its own weight. This combined with the road conditions can place additional pressure on different components. In this event, the movement led to a component failing. The tip section then opened on the transporter into the live traffic lane with the potential to cause serious harm.
